Flood Control Project Maintenance
2009 Structure Summary Report
Overall Unit and Item Ratings

Lower San Joaquin Levee District

Flood Control Project Maintenance
Unit Cover Sheet
2009 Structure Inspection Results

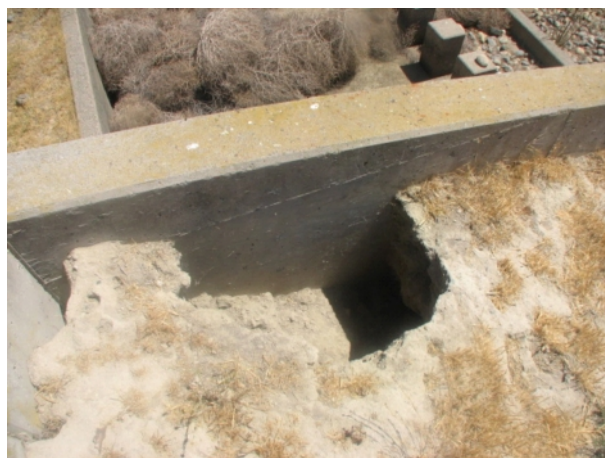
richard_20090708_2.jpg

Looking at minor erosion on the left wing wall

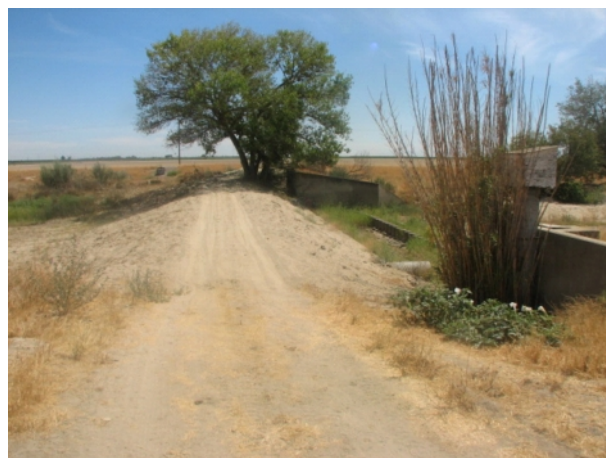
richard_20090708_8.jpg

Looking at seasonal sand dam on the upstream side of the structure

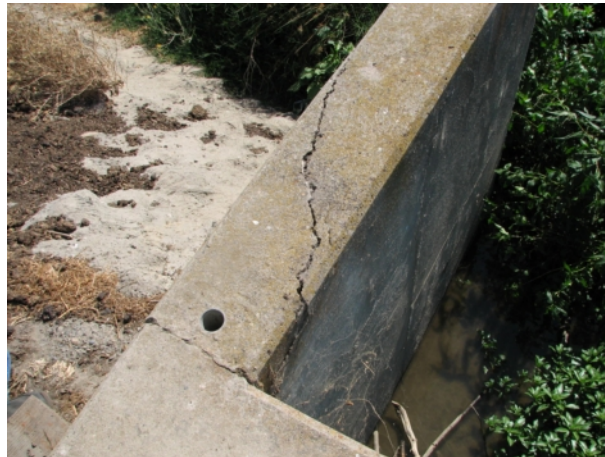
Levee Mile Report Line	6
Start Levee Mile	
End Levee Mile	
Location	
Category	Structures
Item	Concrete Surfaces
Crack on the downstream north wing wall.	
richard_20090708_12.JPG

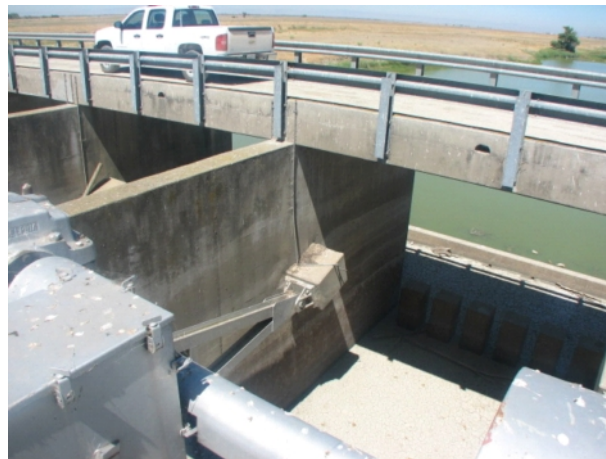
Levee Mile Report Line	6
Start Levee Mile	
End Levee Mile	
Location	
Category	Structures
Item	Sluice/Slide Gates
Looking at lube conduit disconnected from hing point at gate.	
richard_20090803_65.jpg

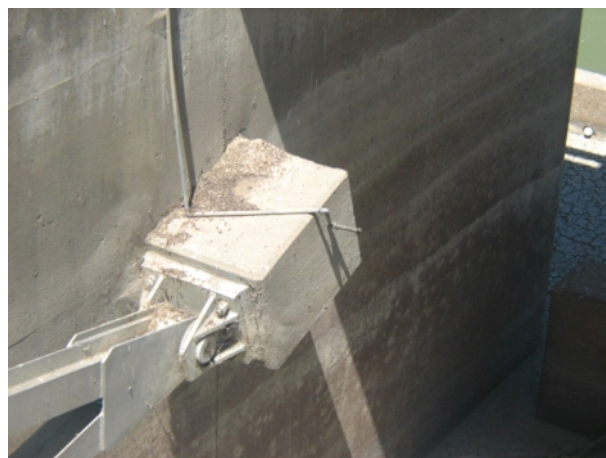
Levee Mile Report Line	6
Start Levee Mile	
End Levee Mile	
Location	
Category	Structures
Item	Sluice/Slide Gates
Looking at lube port disconnected from hing point of gate.	
richard_20090803_66.jpg

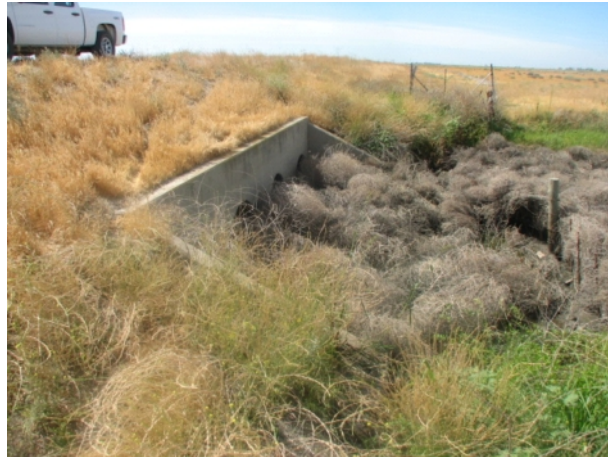
Levee Mile Report Line	2
Start Levee Mile	
End Levee Mile	
Location	
Category	Structures
Item	Vegetation & Obstructions
Looking at pipe inlet blocked with tumble weeds.	
richard_20090708_23.jpg

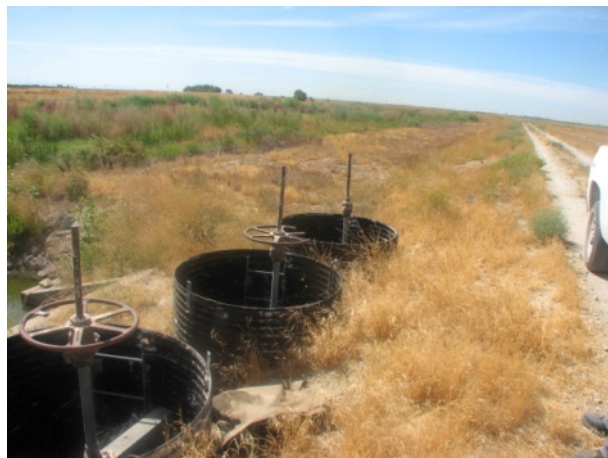
Levee Mile Report Line	7
Start Levee Mile	
End Levee Mile	
Location	
Category	Structures
Item	Manual Gate Operators
Looking at broken and missing screw gate wheels.	
richard_20090708_22.jpg

LMR No.	Levee Mile		Category	Item	Location *	Rating **	Action/Comment	GPS Latitude/Longitude		Photo	Issue No.
	Start	End						Start	End		
1			Structures	Photo Documentation				36.975460 ° -120.359655 °	36.975460 ° -120.359655 °	Y	8
2			Structures	Vegetation & Obstructions		A		° °	° °	Y	7
3			Structures	Revetments		A		° °	° °		5
4			Structures	Encroachments		A		° °	° °		6
5			Structures	Culverts: Inlets / Outlets		A		° °	° °		2
6			Structures	Flap Gates		A		° °	° °	Y	3
7			Structures	Manual Gate Operators		M	Inspector Comments: Screw gate control wheel are missing and broke. Need to repair or replace gate control wheel.	° °	° °	Y	4

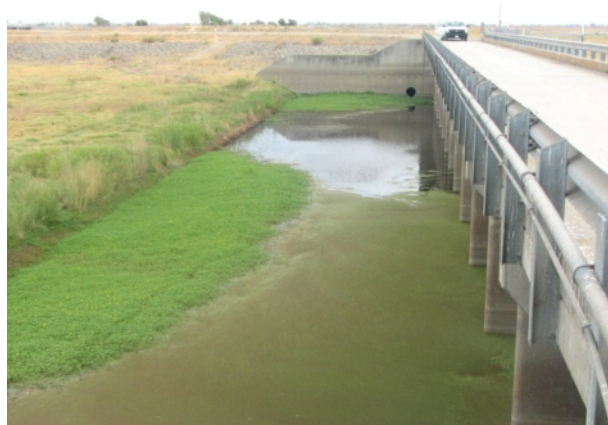
Levee Mile Report Line	4
Start Levee Mile	
End Levee Mile	
Location	
Category	Structures
Item	Revetments
Looking at vegetation growth on the revetment on the upstream side of the structure	
richard_20090708_27.jpg

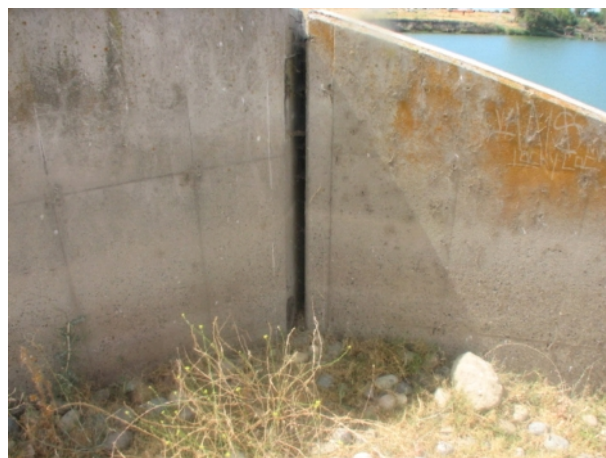
Levee Mile Report Line	6
Start Levee Mile	
End Levee Mile	
Location	
Category	Structures
Item	Monolith Joints
Looking at left bank wing wall monolith joint	
richard_20090708_29.jpg

LMR No.	Levee Mile		Category	Item	Location *	Rating **	Action/Comment	GPS Latitude/Longitude		Photo	Issue No.
	Start	End						Start	End		
1			Structures	Photo Documentation				°	°	Y	6
2			Structures	Vegetation & Obstructions		A		°	°		4
3			Structures	Encroachments		A		°	°		3
4			Structures	Concrete Surfaces		A		°	°		5
5			Structures	Concrete Foundations		A		37.202181 ° -120.755237 °	37.202181 ° -120.755237 °		1
6			Structures	Monolith Joints		A	Inspector Comments: Need to monitor joint for movement	°	°	Y	2

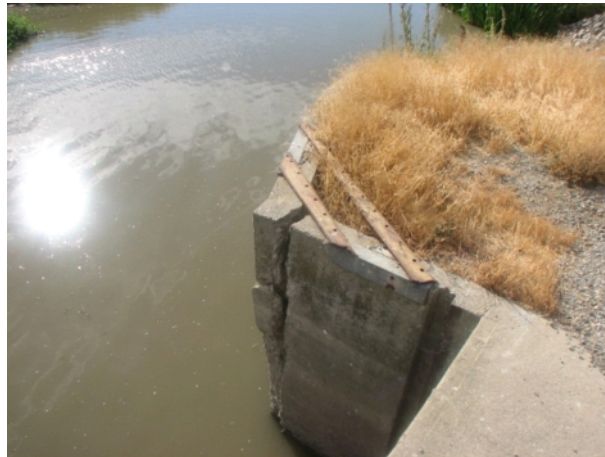
Levee Mile Report Line	4
Start Levee Mile	
End Levee Mile	
Location	
Category	Structures
Item	Concrete Surfaces
Looking at damage wing wall on the left bank of the downstream side of the structure	
richard_20090708_31.jpg

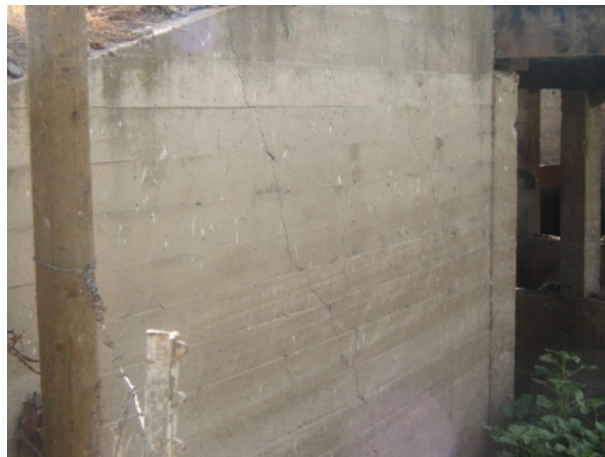
Levee Mile Report Line	4
Start Levee Mile	
End Levee Mile	
Location	
Category	Structures
Item	Concrete Surfaces
Looking at cracks on the right bank on the upstream side of the structure	
richard_20090708_32.jpg

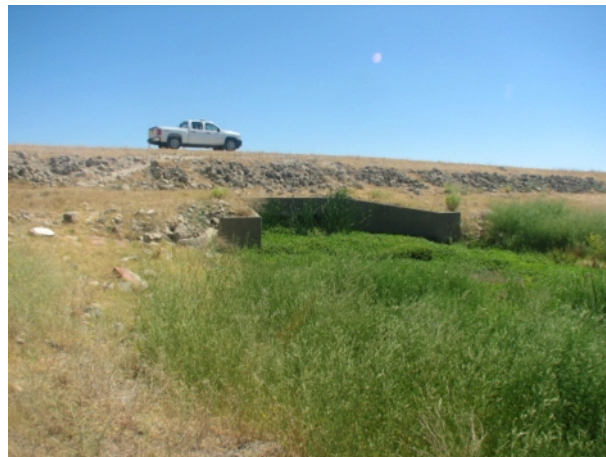
Levee Mile Report Line	2
Start Levee Mile	
End Levee Mile	
Location	
Category	Structures
Item	Vegetation & Obstructions
Looking at downstream of structure, control vegetation	
richard_20090803_60.jpg

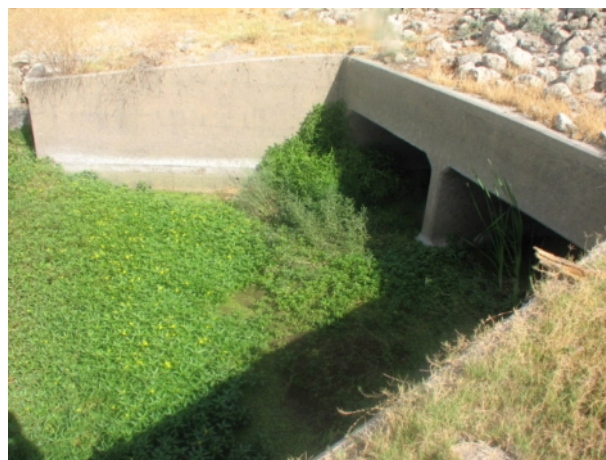
Levee Mile Report Line	3
Start Levee Mile	
End Levee Mile	
Location	
Category	Structures
Item	Revetments
Looking at vegetation on the discharge side of the structure.	
richard_20090708_37.jpg

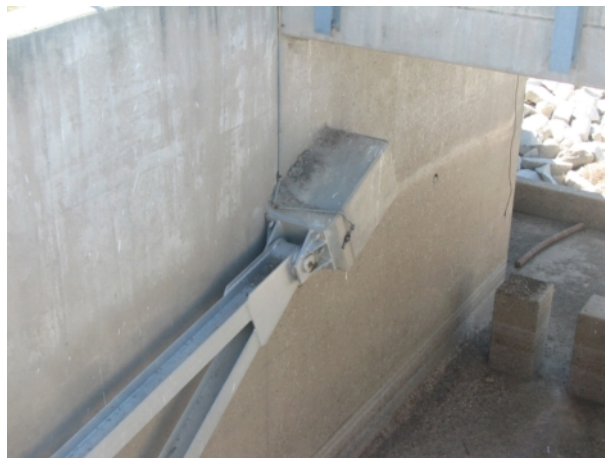
Levee Mile Report Line	10
Start Levee Mile	
End Levee Mile	
Location	
Category	Structures
Item	Sluice/Slide Gates
Looking at lube port conduit extension broken at hing point of gate arm.	
richard_20090805_91.jpg

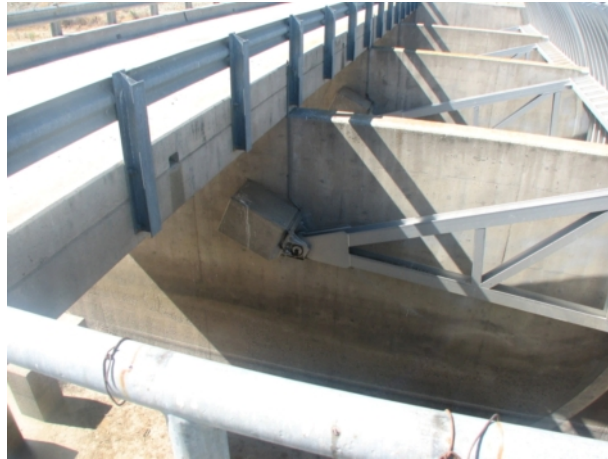
Levee Mile Report Line	11
Start Levee Mile	
End Levee Mile	
Location	
Category	Structures
Item	Sluice/Slide Gates
Looking at broken lube port conduit broken at hing point of gate arm.	
richard_20090805_96.jpg

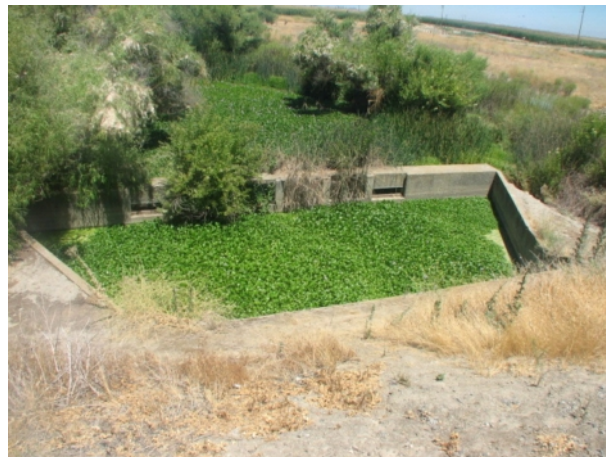
Levee Mile Report Line	1
Start Levee Mile	
End Levee Mile	
Location	
Category	Structures
Item	Photo Documentation
Looking at overview of outlet side of structure and overgrown of vegetation.	
richard_20090803_73.jpg

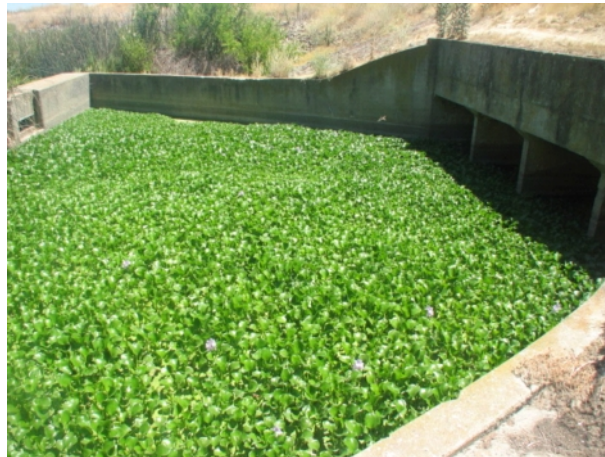
Levee Mile Report Line	3
Start Levee Mile	
End Levee Mile	
Location	
Category	Structures
Item	Vegetation & Obstructions
Looking at overgrown of vegetation at outlet of structure	
richard_20090803_74.jpg

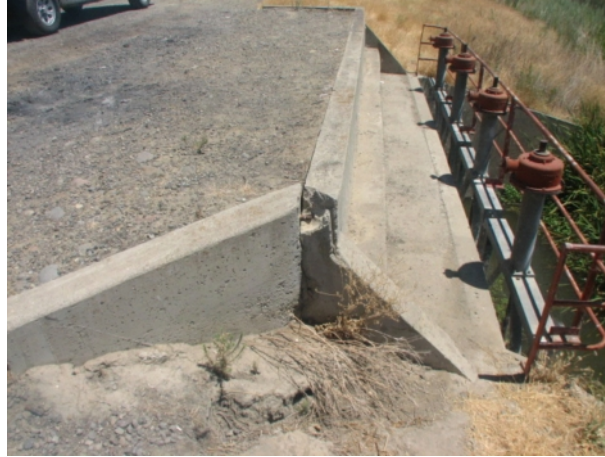
Levee Mile Report Line	11
Start Levee Mile	
End Levee Mile	
Location	
Category	Structures
Item	Concrete Foundations
Looking at damage on the right corner of upstream of structure	
richard_20090803_72.jpg
